*926220*  
**Operation  
TEAPOT**

Project 3.1

RESPONSE of DRAG TYPE EQUIPMENT  
TARGETS in the PRECURSOR ZONE (U)

Issuance Date: October 28, 1959

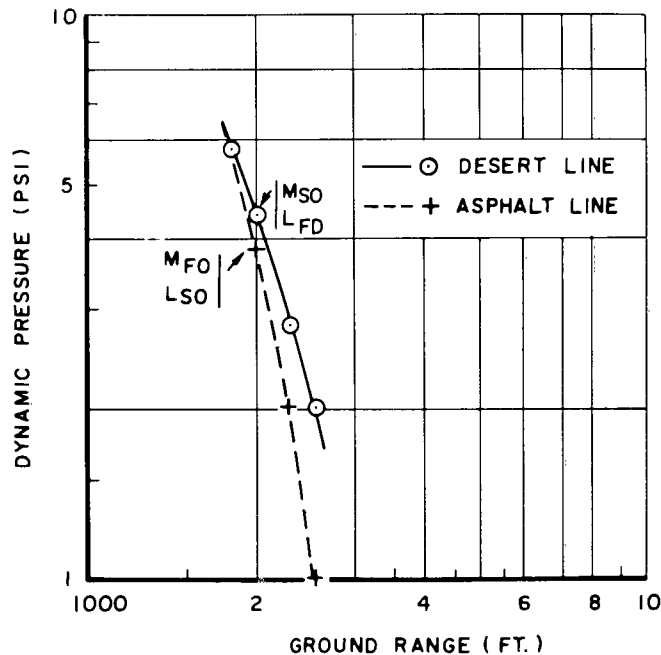
Fig. 4.1 Plot of Damage to 1/4-Ton Trucks on a Dynamic Pressure-Distance Curve, Shot 6

Shown in Figures 4.1 and 4.2 are plots of the damage sustained by vehicles on a dynamic pressure versus distance curve for Shots 6 and 12. Where the degree of damage differed for orientation, (face-on and side-on) at each location it is so noted on the curves by use of subscripts SO and FO. Two surfaces, desert and asphalt, provided a comparison of damage on Shot 6 while on Shot 12, three surfaces, desert, asphalt and water, provided a comparison of damage. On both surfaces of Shot 6 damage to the jeeps was about the same. However, the jeeps were not located well within the precursor zone and no comparison over the total range of damage was obtained. On Shot 12, the degree of damage was not too greatly different over the three surfaces. Examina-

tion of the curves indicates a dynamic pressure of about 9 psi is required to cause severe damage to jeeps. Also, on the desert line at the 3000 foot station, the moderate damage to the side-on vehicle along with the large displacement noted implies that this value of dynamic pressure possibly is too low.

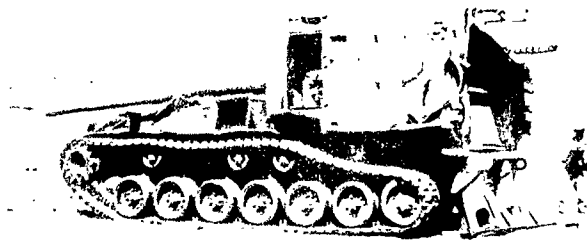
Fig. D.50 - T97, Face-on, Breaks Off, 2050 ft  
From Ground Zero, After Shot 13.
